# DEPARTMENT OF WATER RESOURCES

Southern Field Division East Branch Extension  
Cherry Valley Pump Station

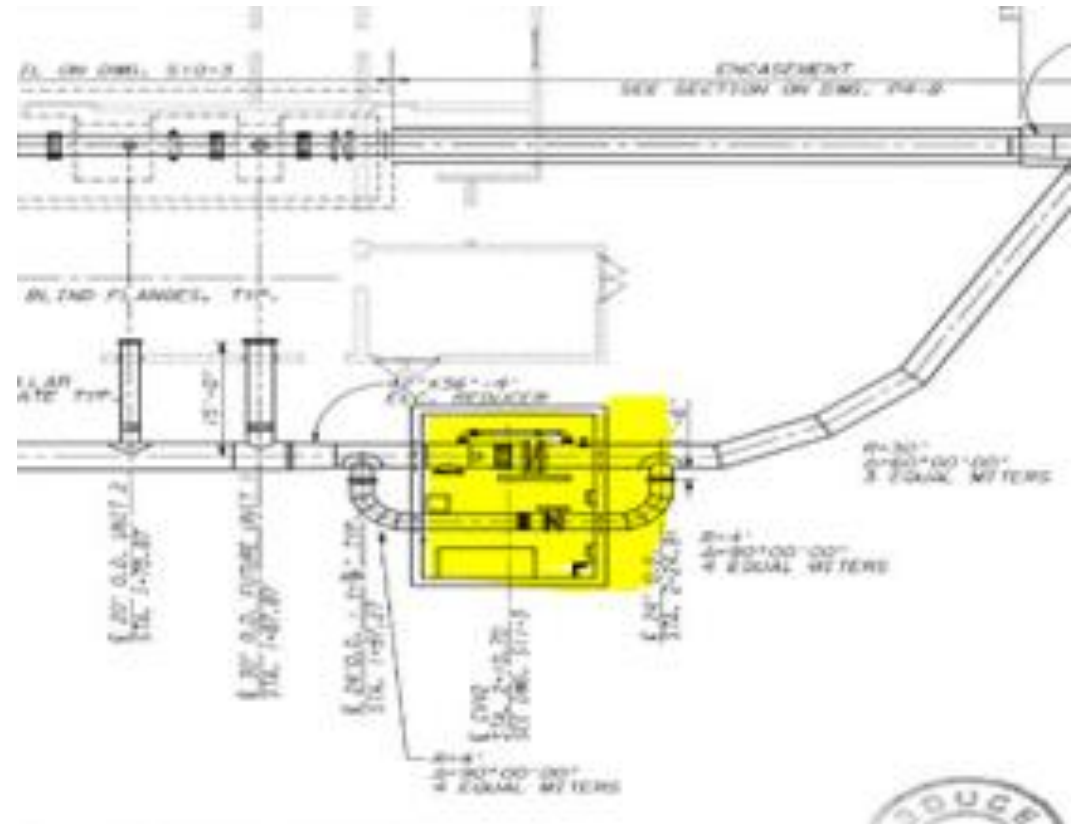
- 12/3/2020
  - SCE power shutdown due to red flag alert.
  - Battery back up depleted.
- 12/4/2020
  - SCE power restored.
  - Staff discovered HPU for bypass valves BFV-5 and BFV-7 was in alarm.
  - Electricians entered vault to reset HPU (hydraulic power unit). After resetting HPU, both bypass valves opened, releasing approximately 40 CFS.

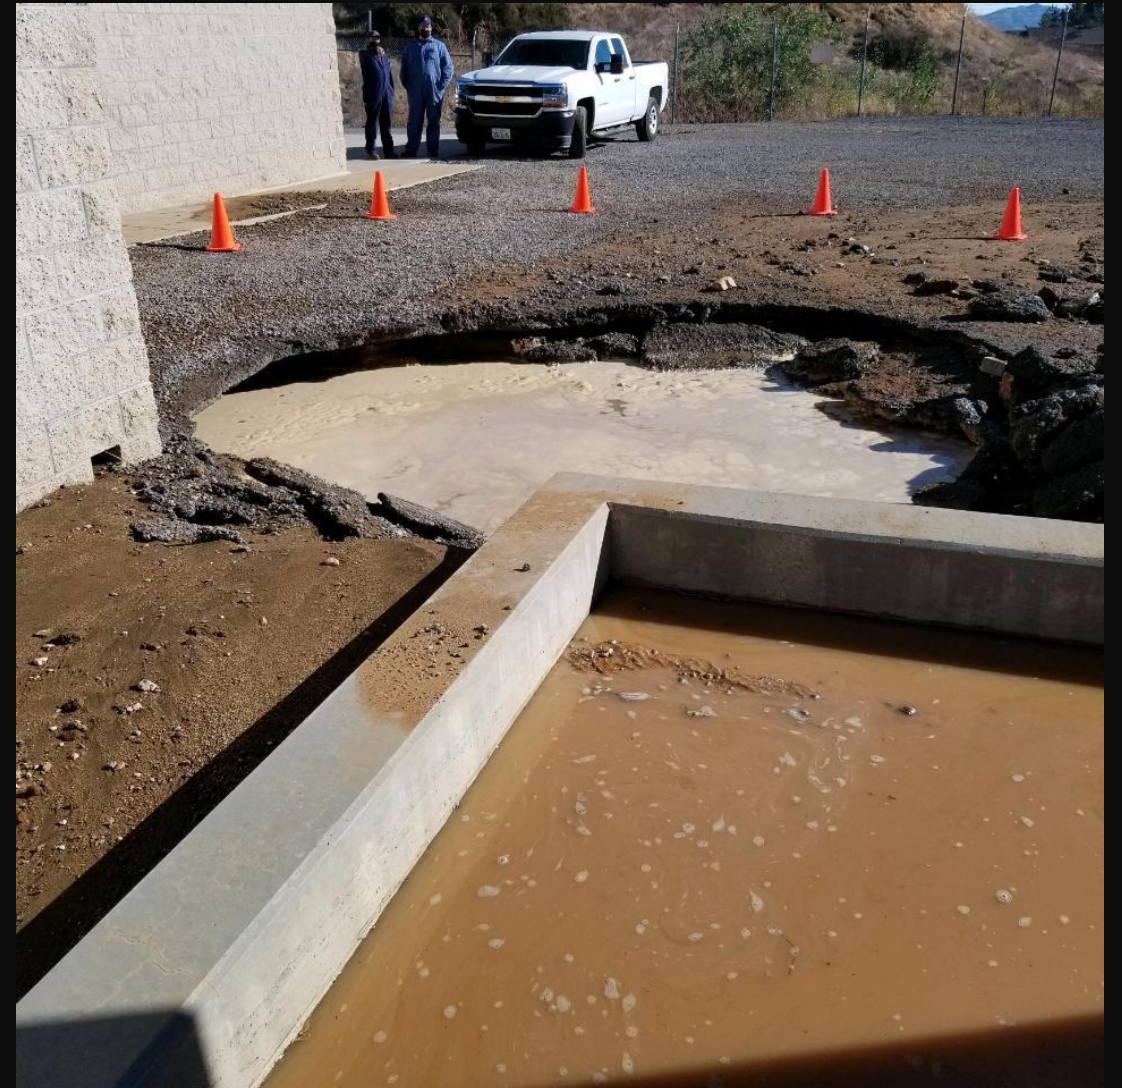
- Bypass valve BFV-5 was closed then bypass valve BFV- 7.
- When the electricians exited the vault, they noticed water near the transformer pad.
- The plant was isolated by closing the inlet and outlet valves.
- It was confirmed that the bulkhead failed.

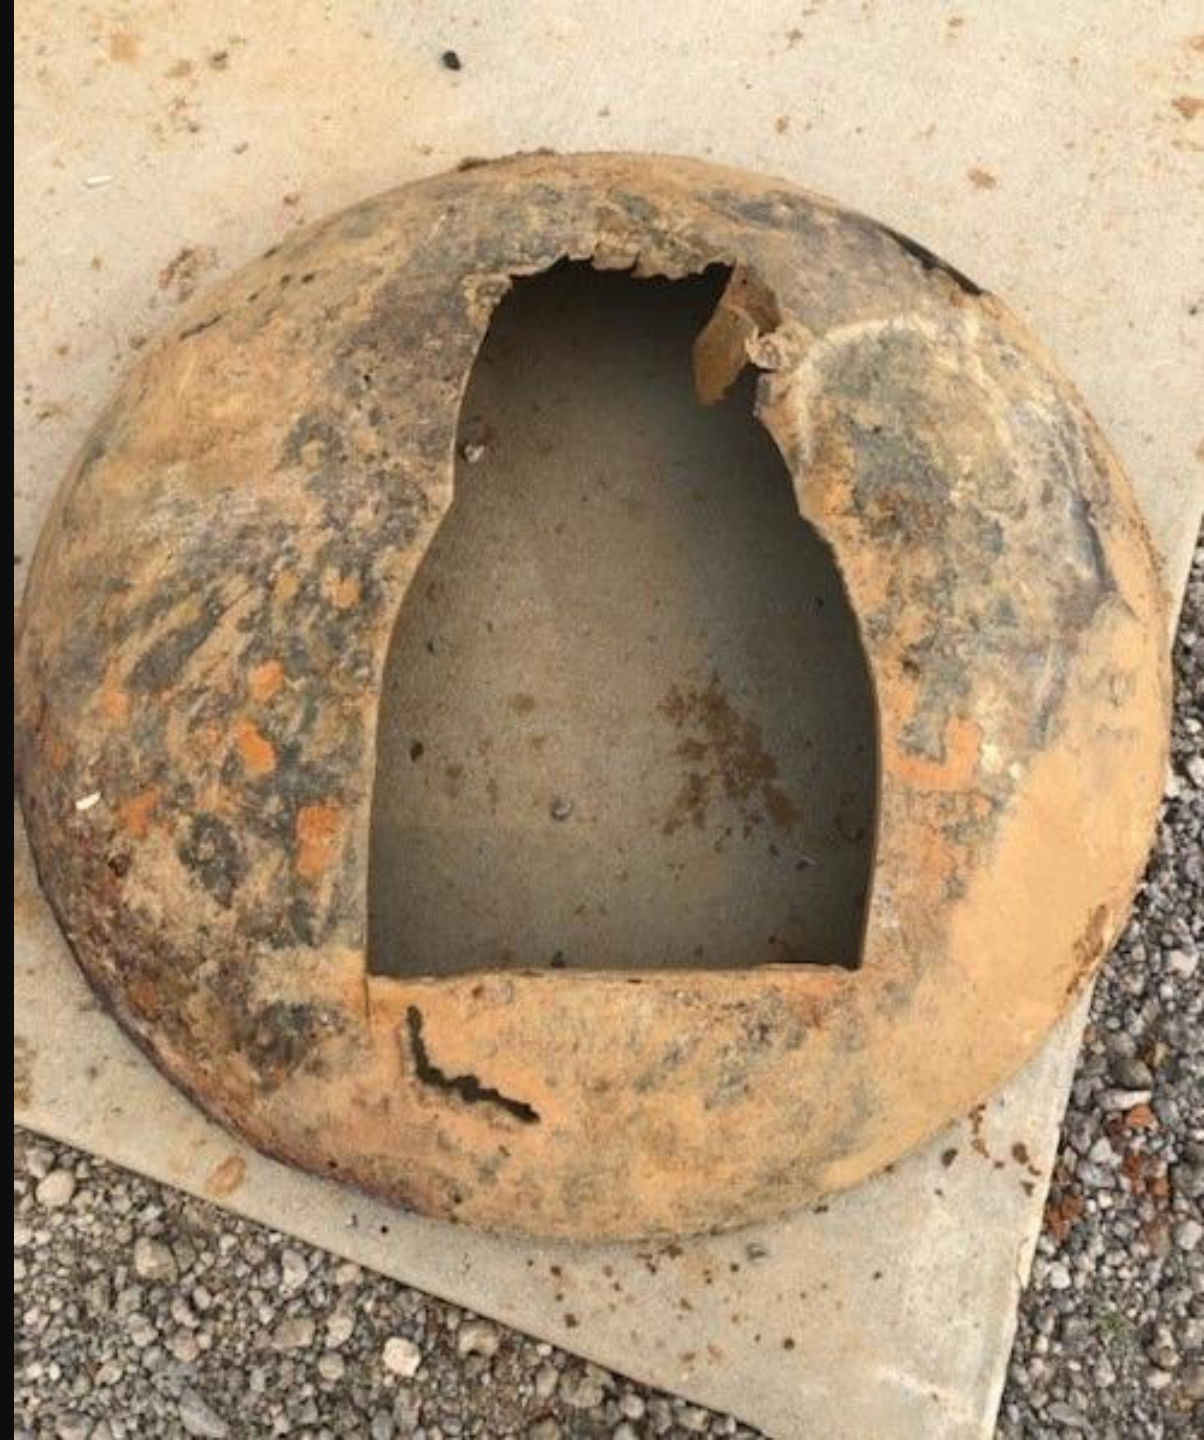
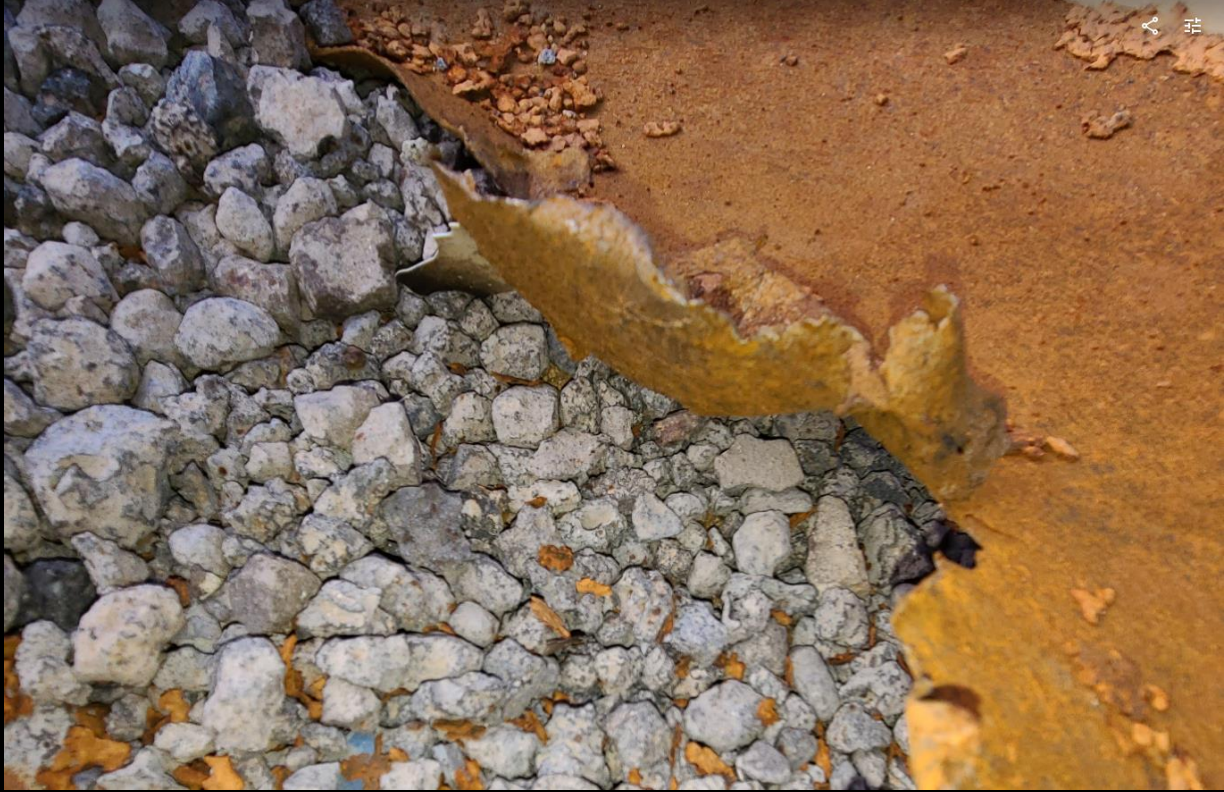
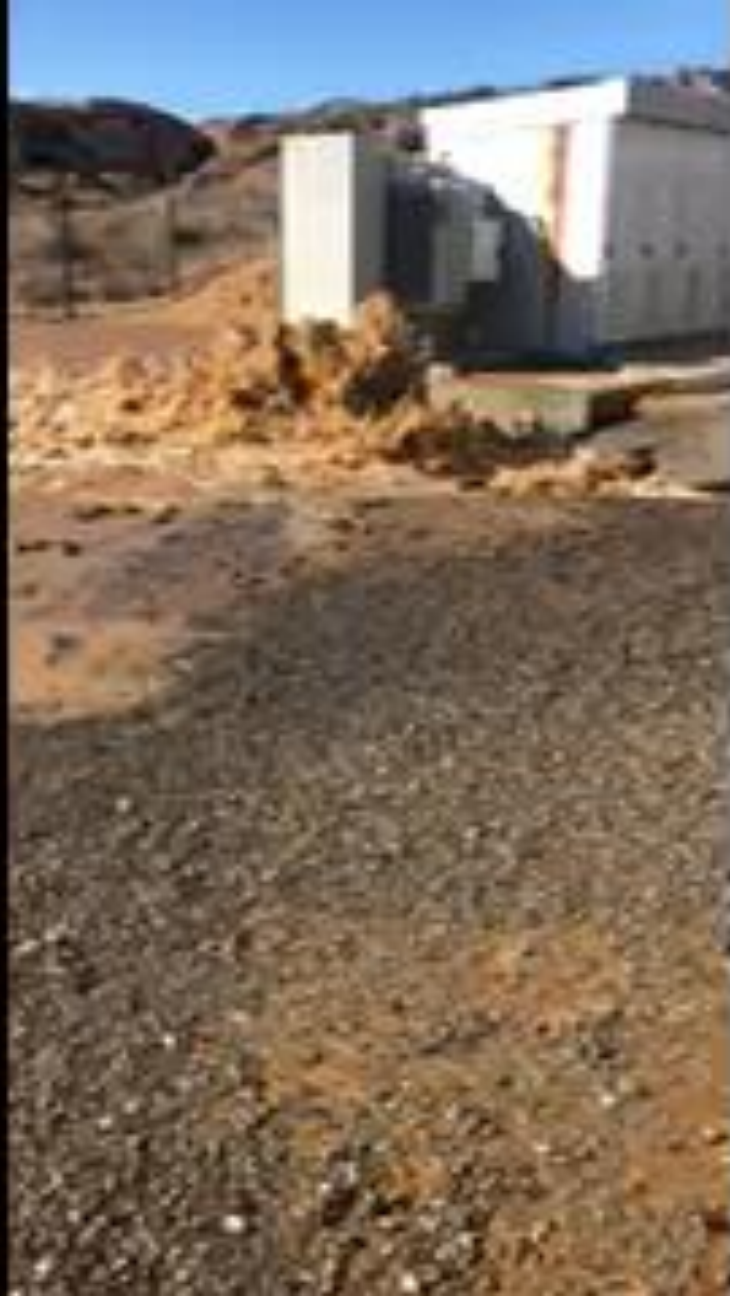
- Due to Power loss, and no permanent SEG (standby emergency generator) installed, Cherry Valley lost PLC (program logic controller) communication to the bypass HPU.
  - Upon restoring power and resetting the HPU both bypass valves opened. Bypass BFV- 5 was closed then BFV-7.
  - BFV-7 closed much faster than expected causing water hammer, which was with in the designed pressure thresholds.
  - Root cause leading to the failure can be attributed to corrosion inside the bulkhead.
-
