# SGPWA Recharge Facility

# Maintenance Review

February 8, 2021  
Engineering Workshop

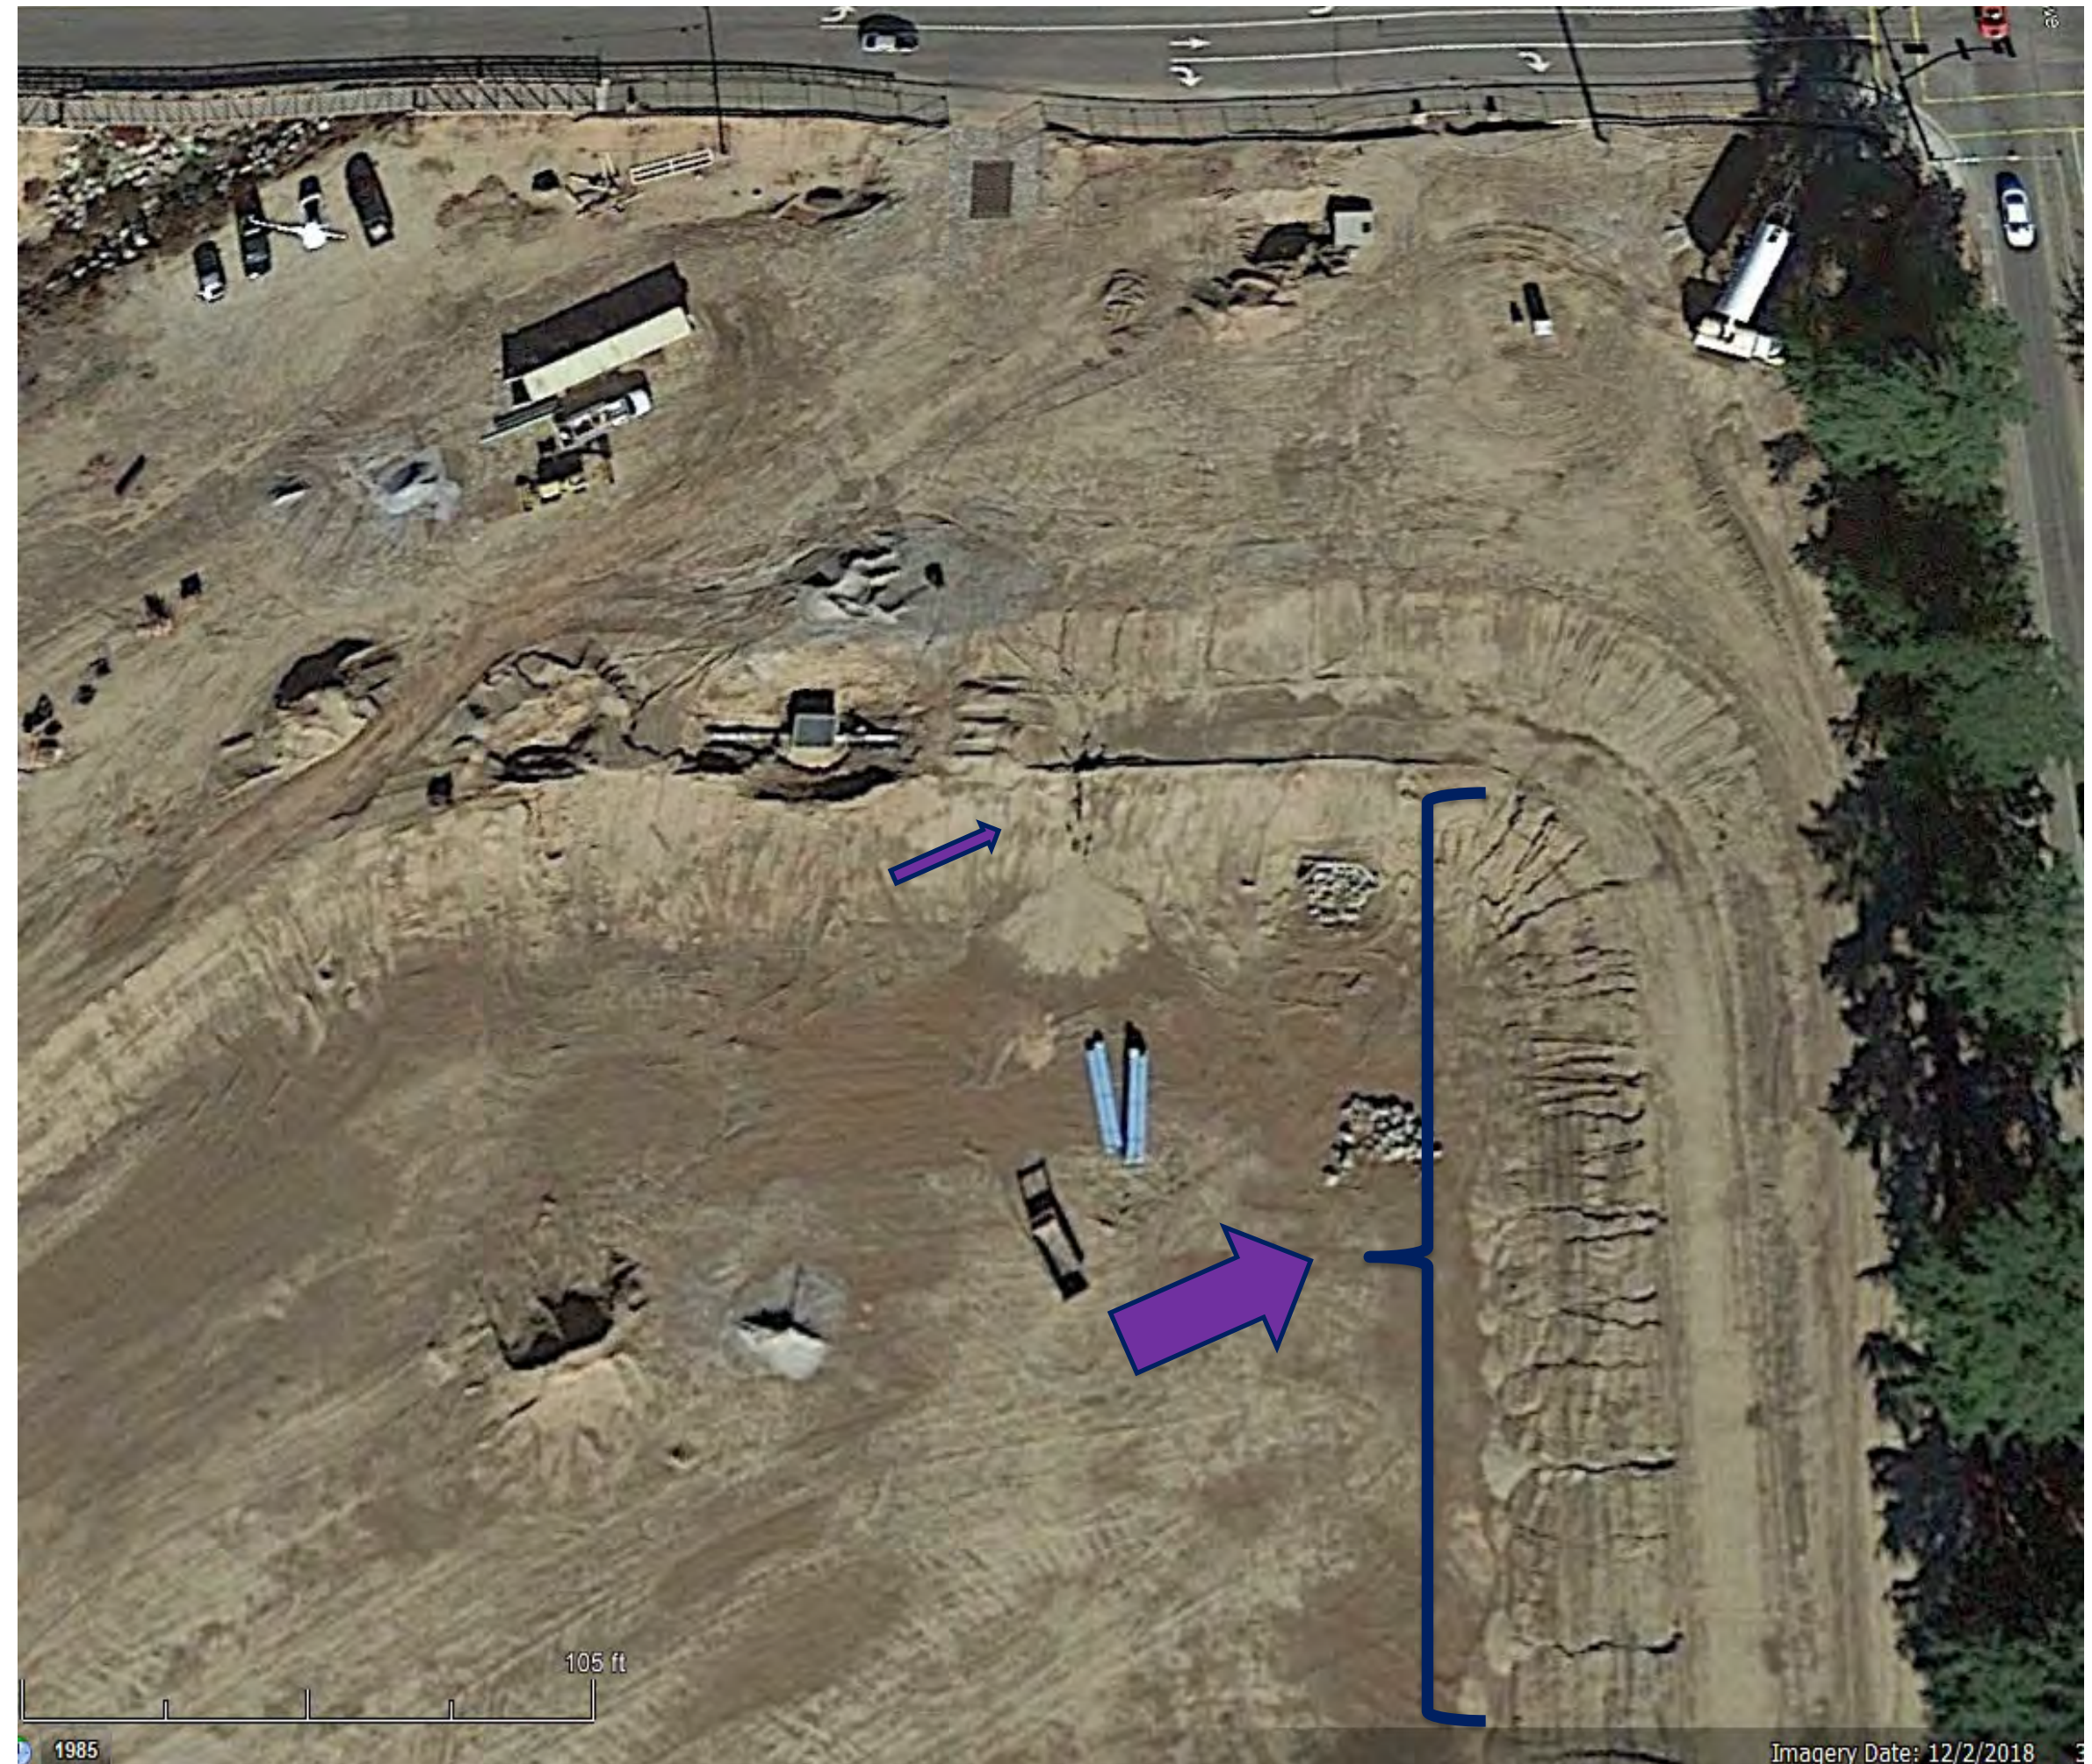
Aerial Image December 2018 during pond construction.

Note erosional features on north and east sides of ponds.

Demonstrating that this is not unusual and does not appear to be getting progressively worse.

Grass/vegetation on slopes appear to help stabilize basin walls.

No maintenance recommended at this time. Continue to monitor.
