Brookside Recharge Protection

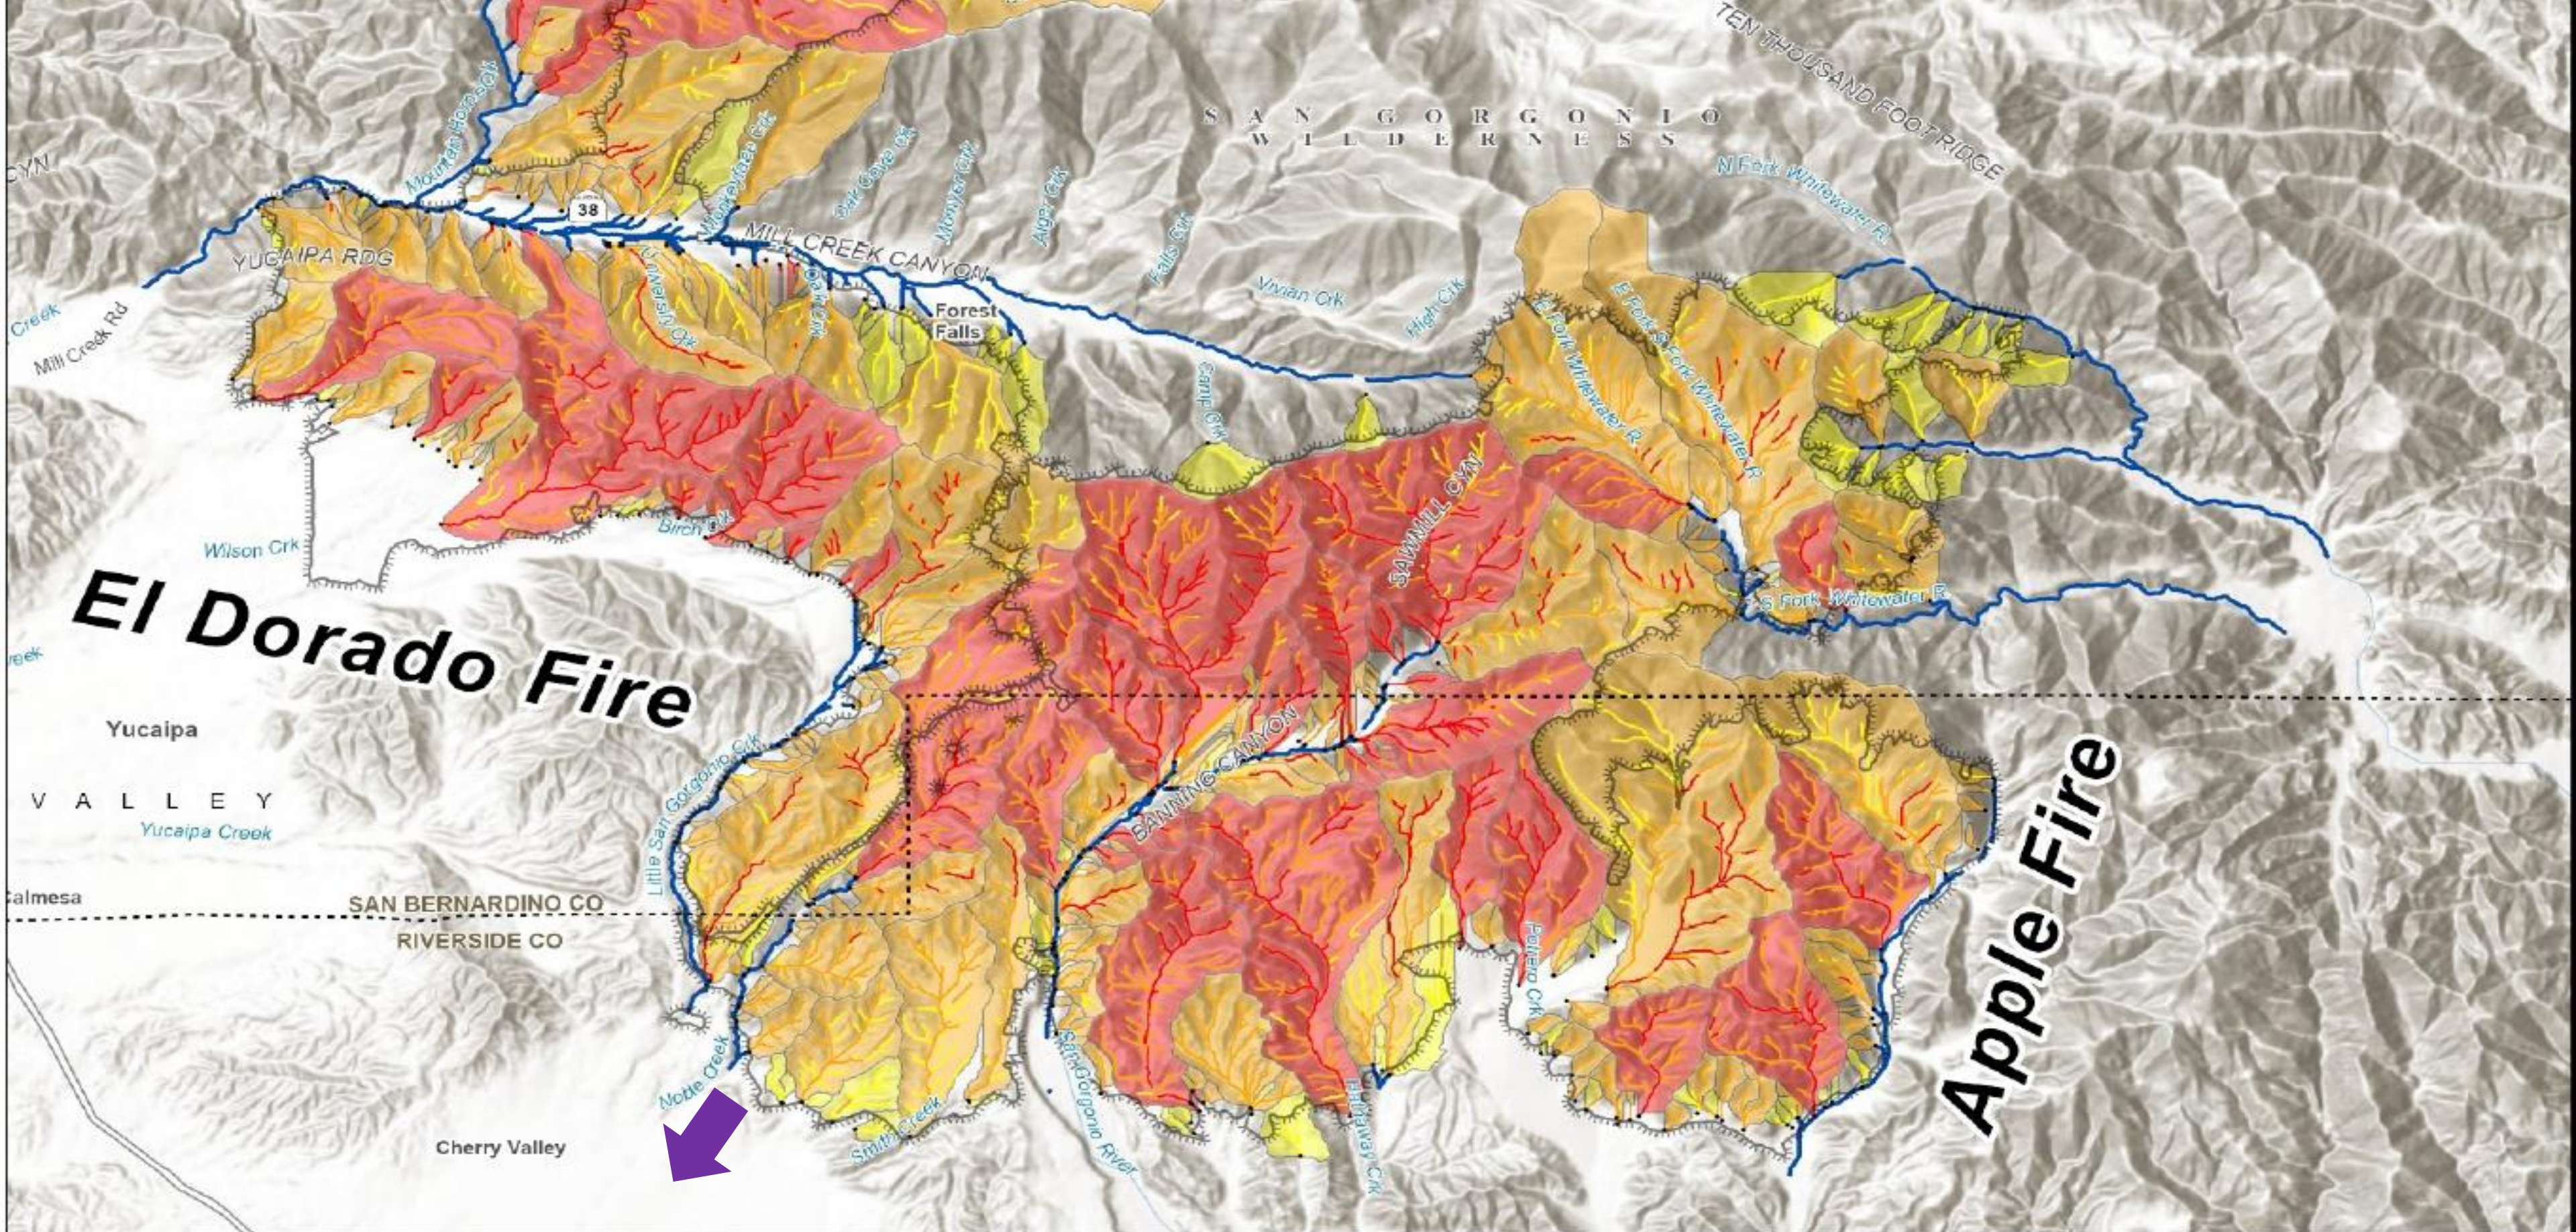
<p>Segment Combined Hazard 15 min 24mm/hr</p> <ul style="list-style-type: none"> — Low — Moderate — High 	<p>Basin Combined Hazard 15 min 24mm/hr</p> <ul style="list-style-type: none"> ■ Low ■ Moderate ■ High 	<ul style="list-style-type: none"> Fire Perimeter USGS Watchstream Basin Outlet 	<p>USGS Debris Flow 15 min 24 mm/hr El Dorado Fire Apple Fire CA-BDF-013409 CA-RRU-096640</p>		<p>Data represents debris flow probability and volume as a combined hazard, based on response to a design rainstorm with a peak 15 minute rainfall intensity of 24mm/hr (1 in/hr).</p> <p>USGS Watchstreams indicate potential sediment laden flood hazard as the basin area exceeds debris flow model limits.</p>	<p>N</p>
---	---	---	---	--	--	----------

Post-fire concerns are:

- High erosion events
- Potential debris flows
- Impacts on infrastructure
- Uncertain long-term effects on water supply

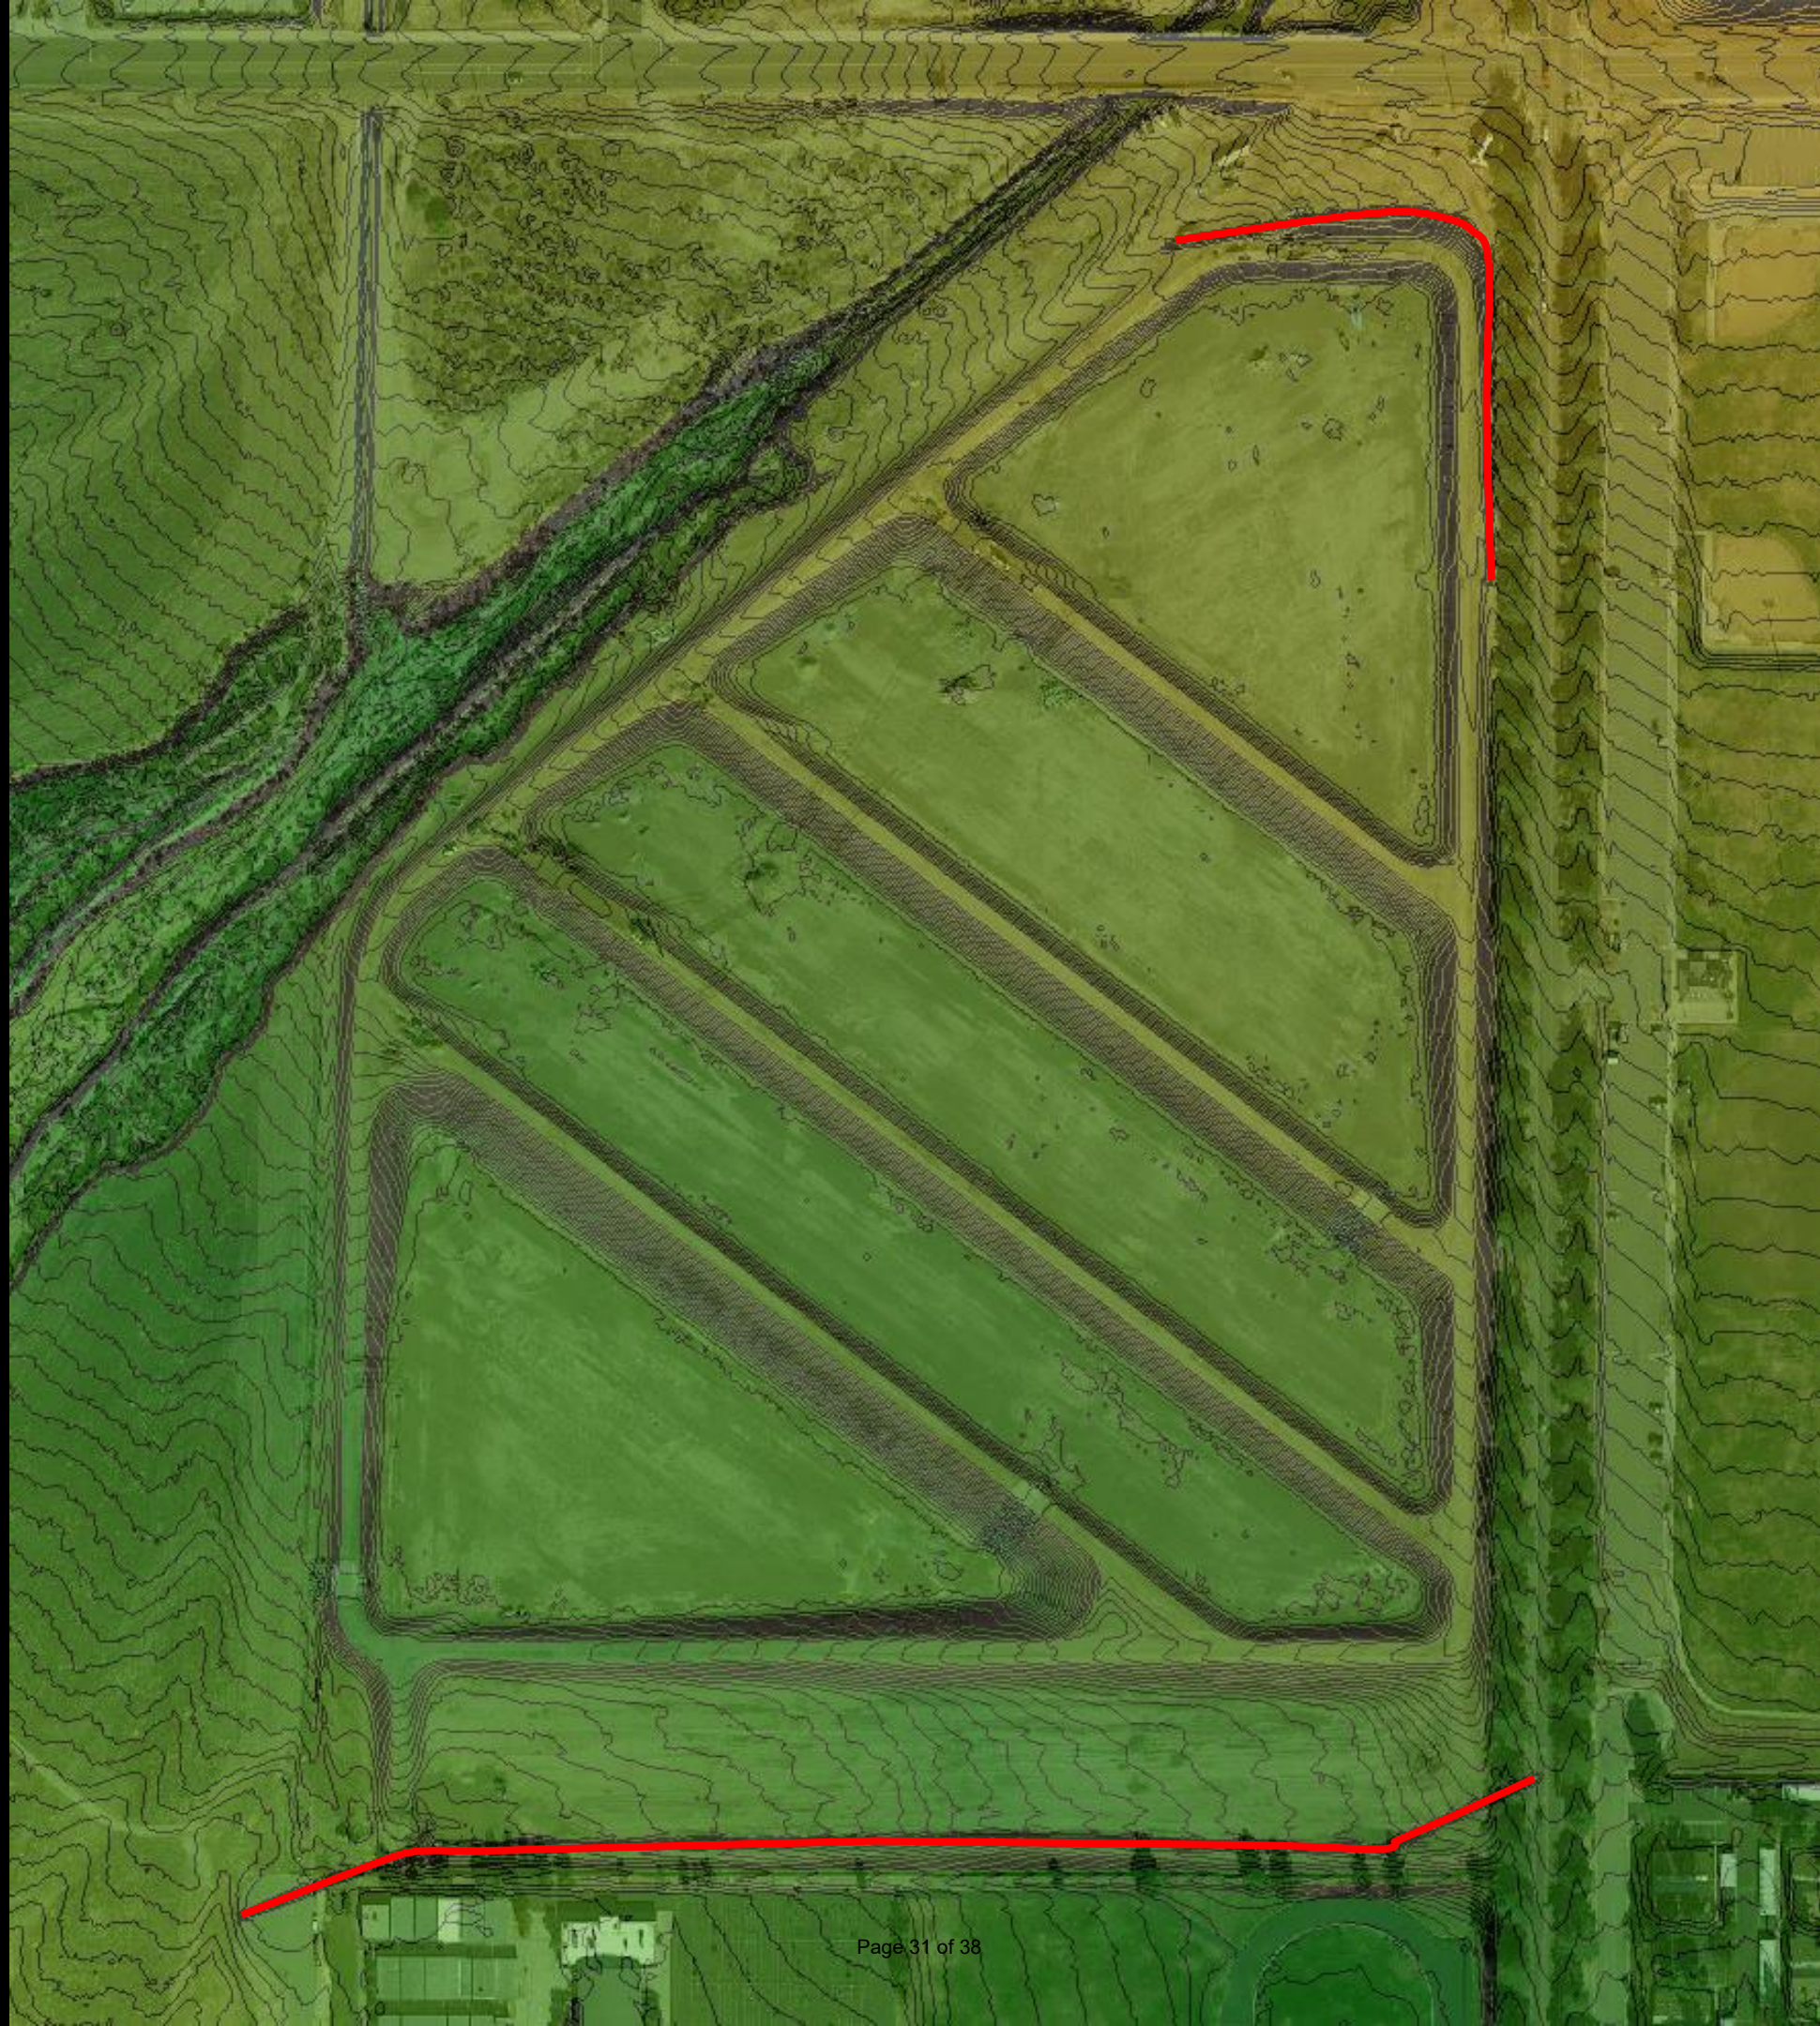
Selected: 'depth'

Max

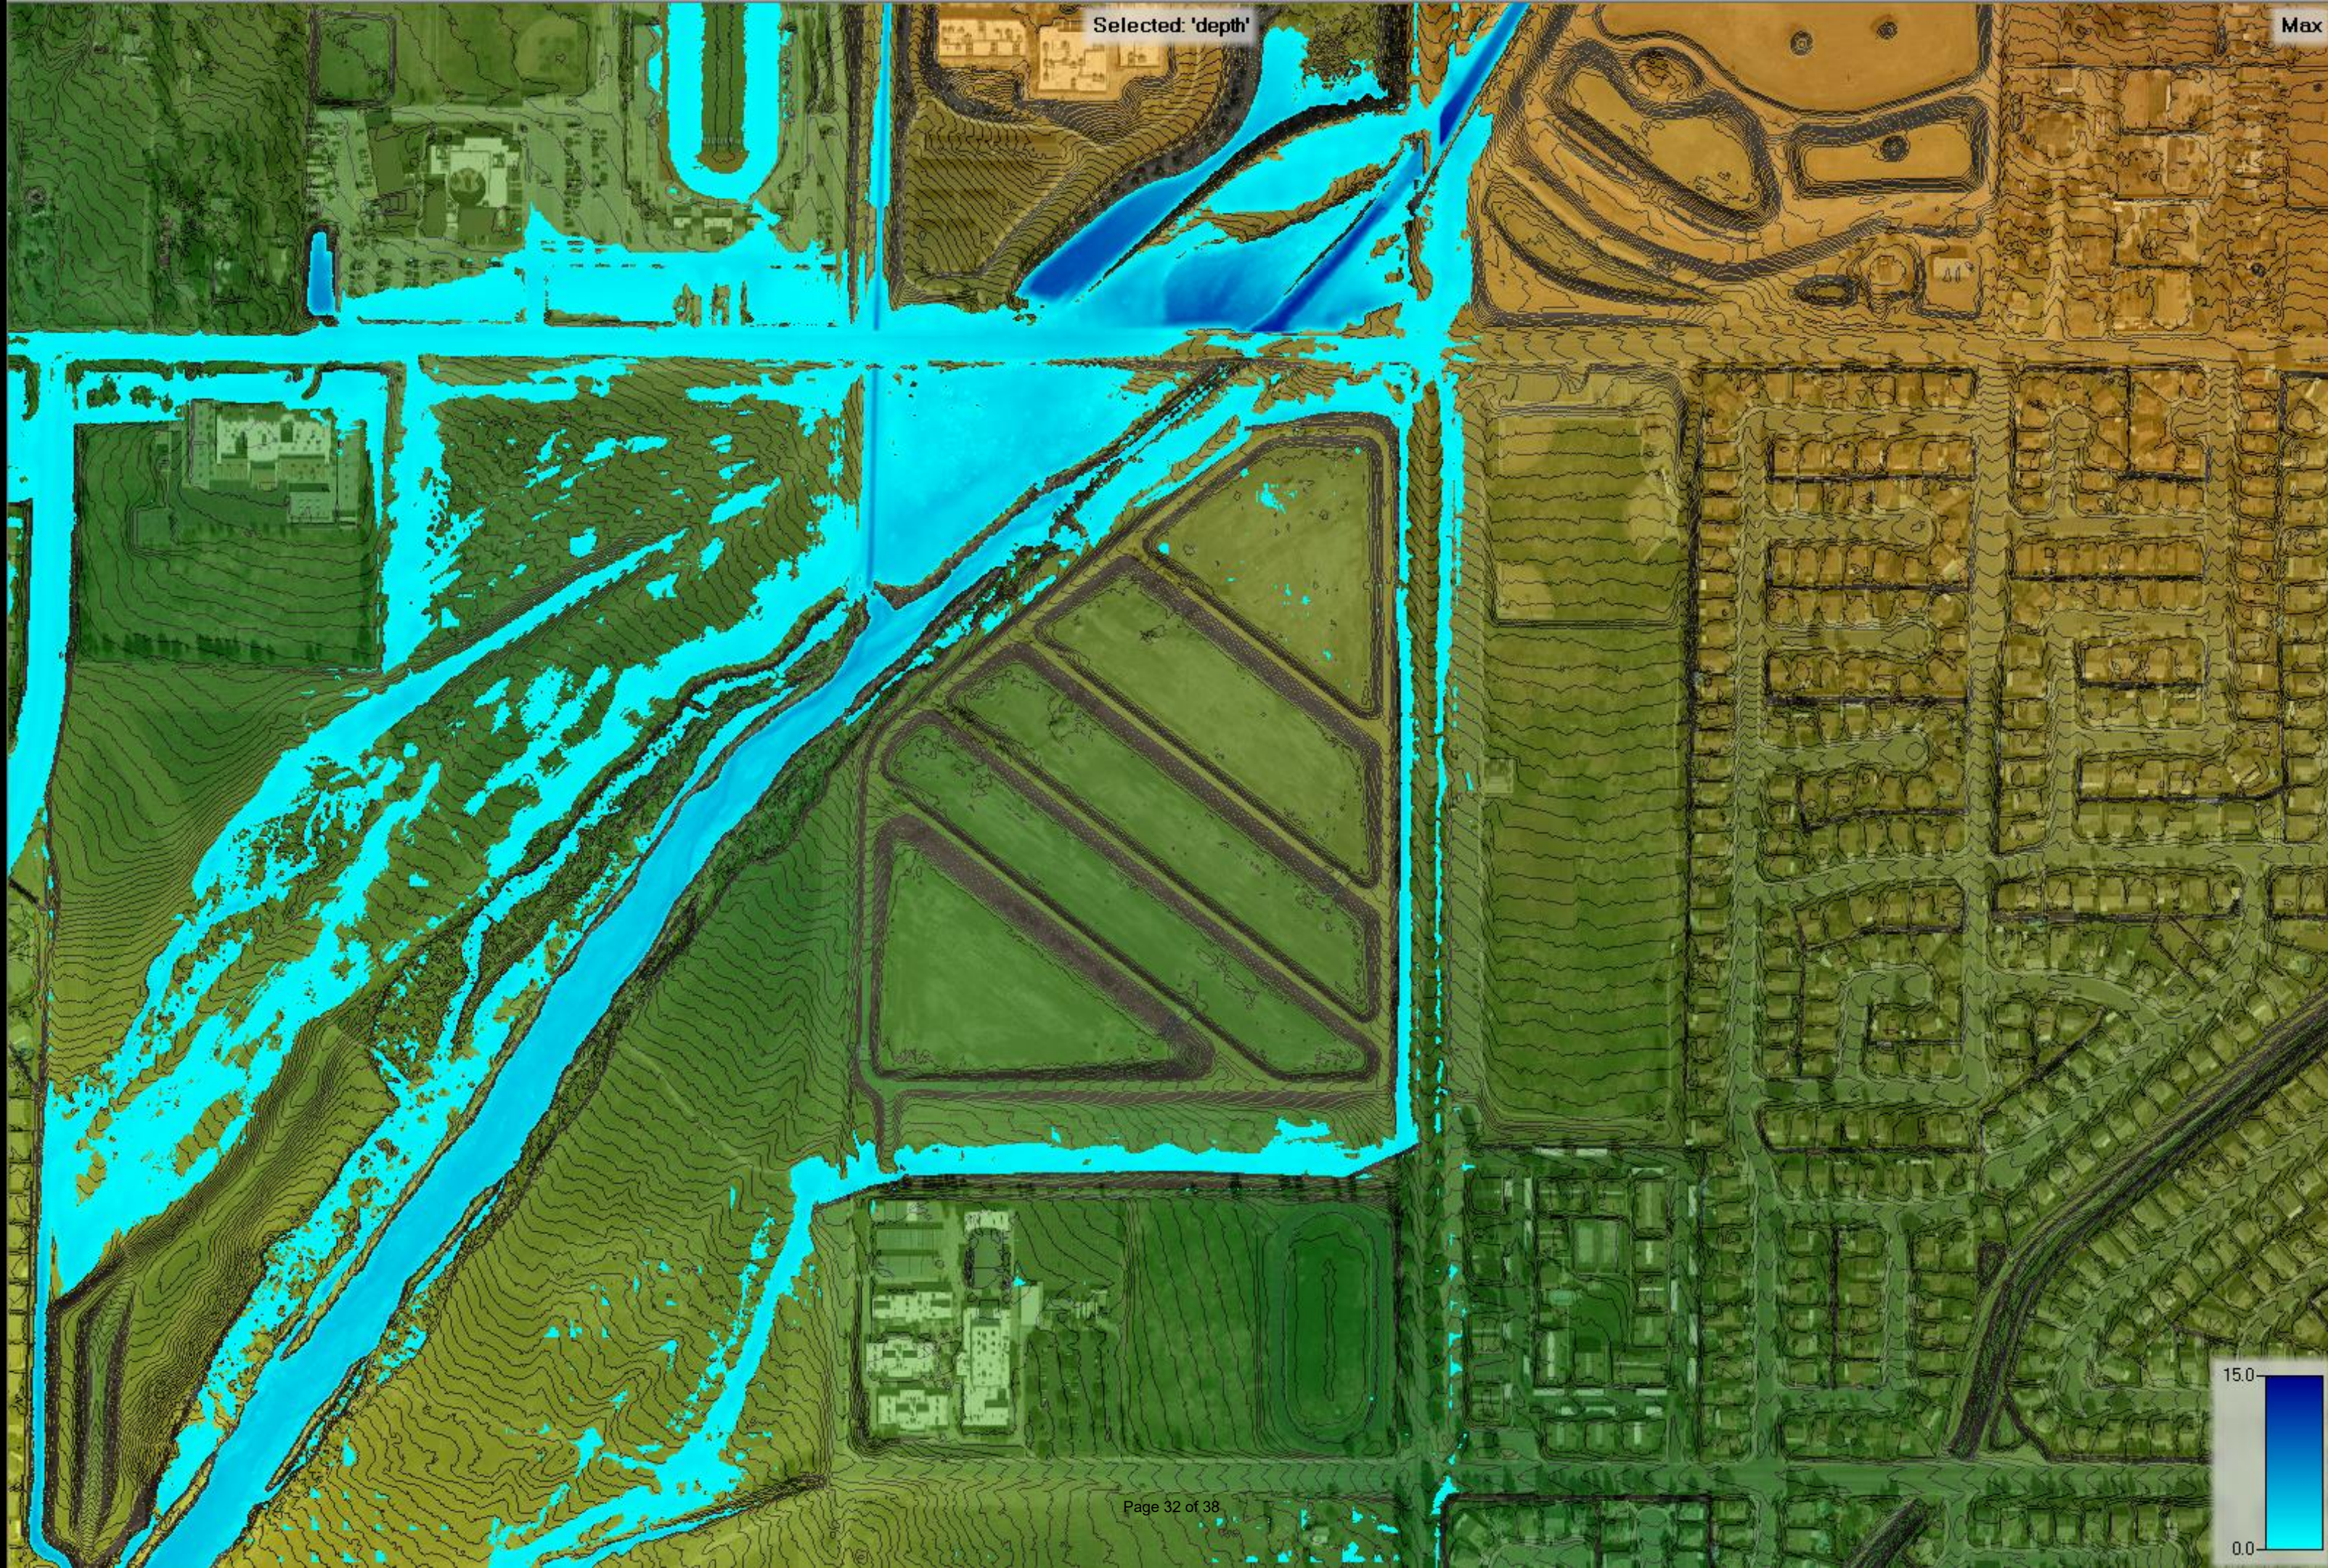
North of Mountain View Middle School

Looking West

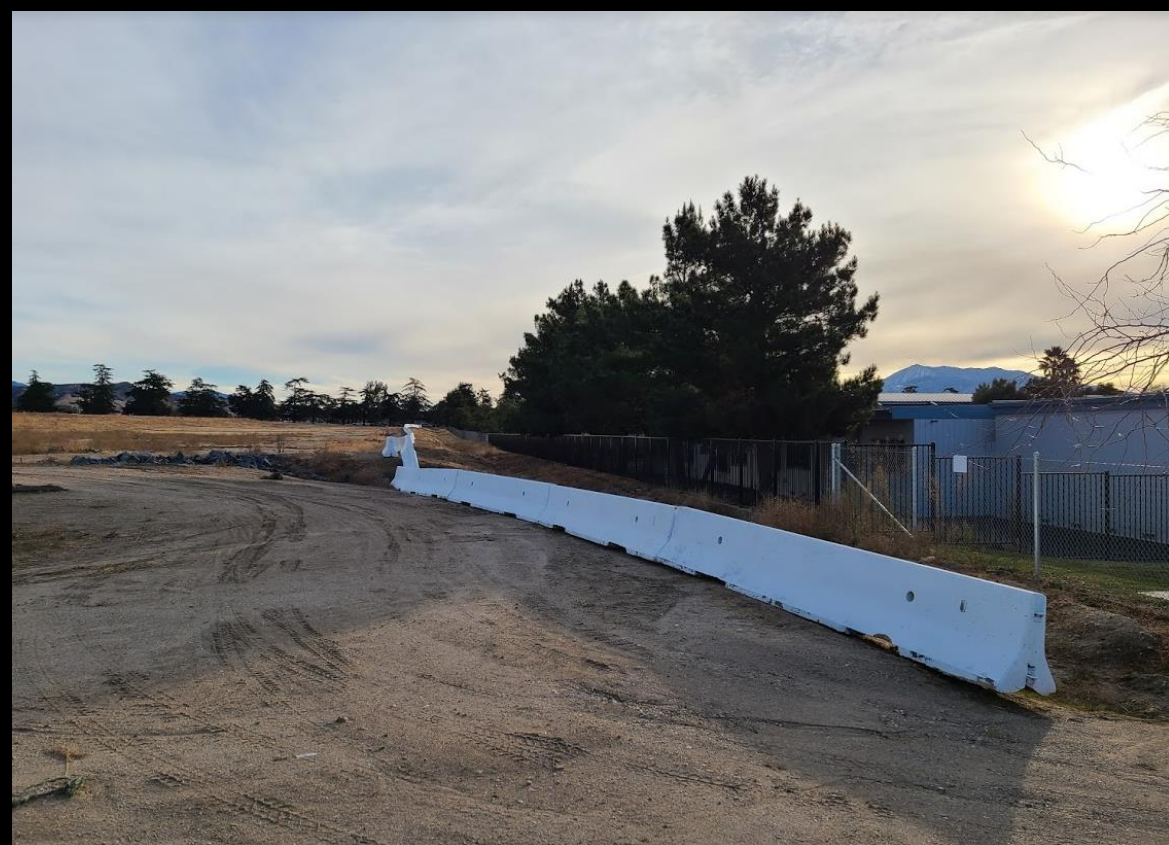
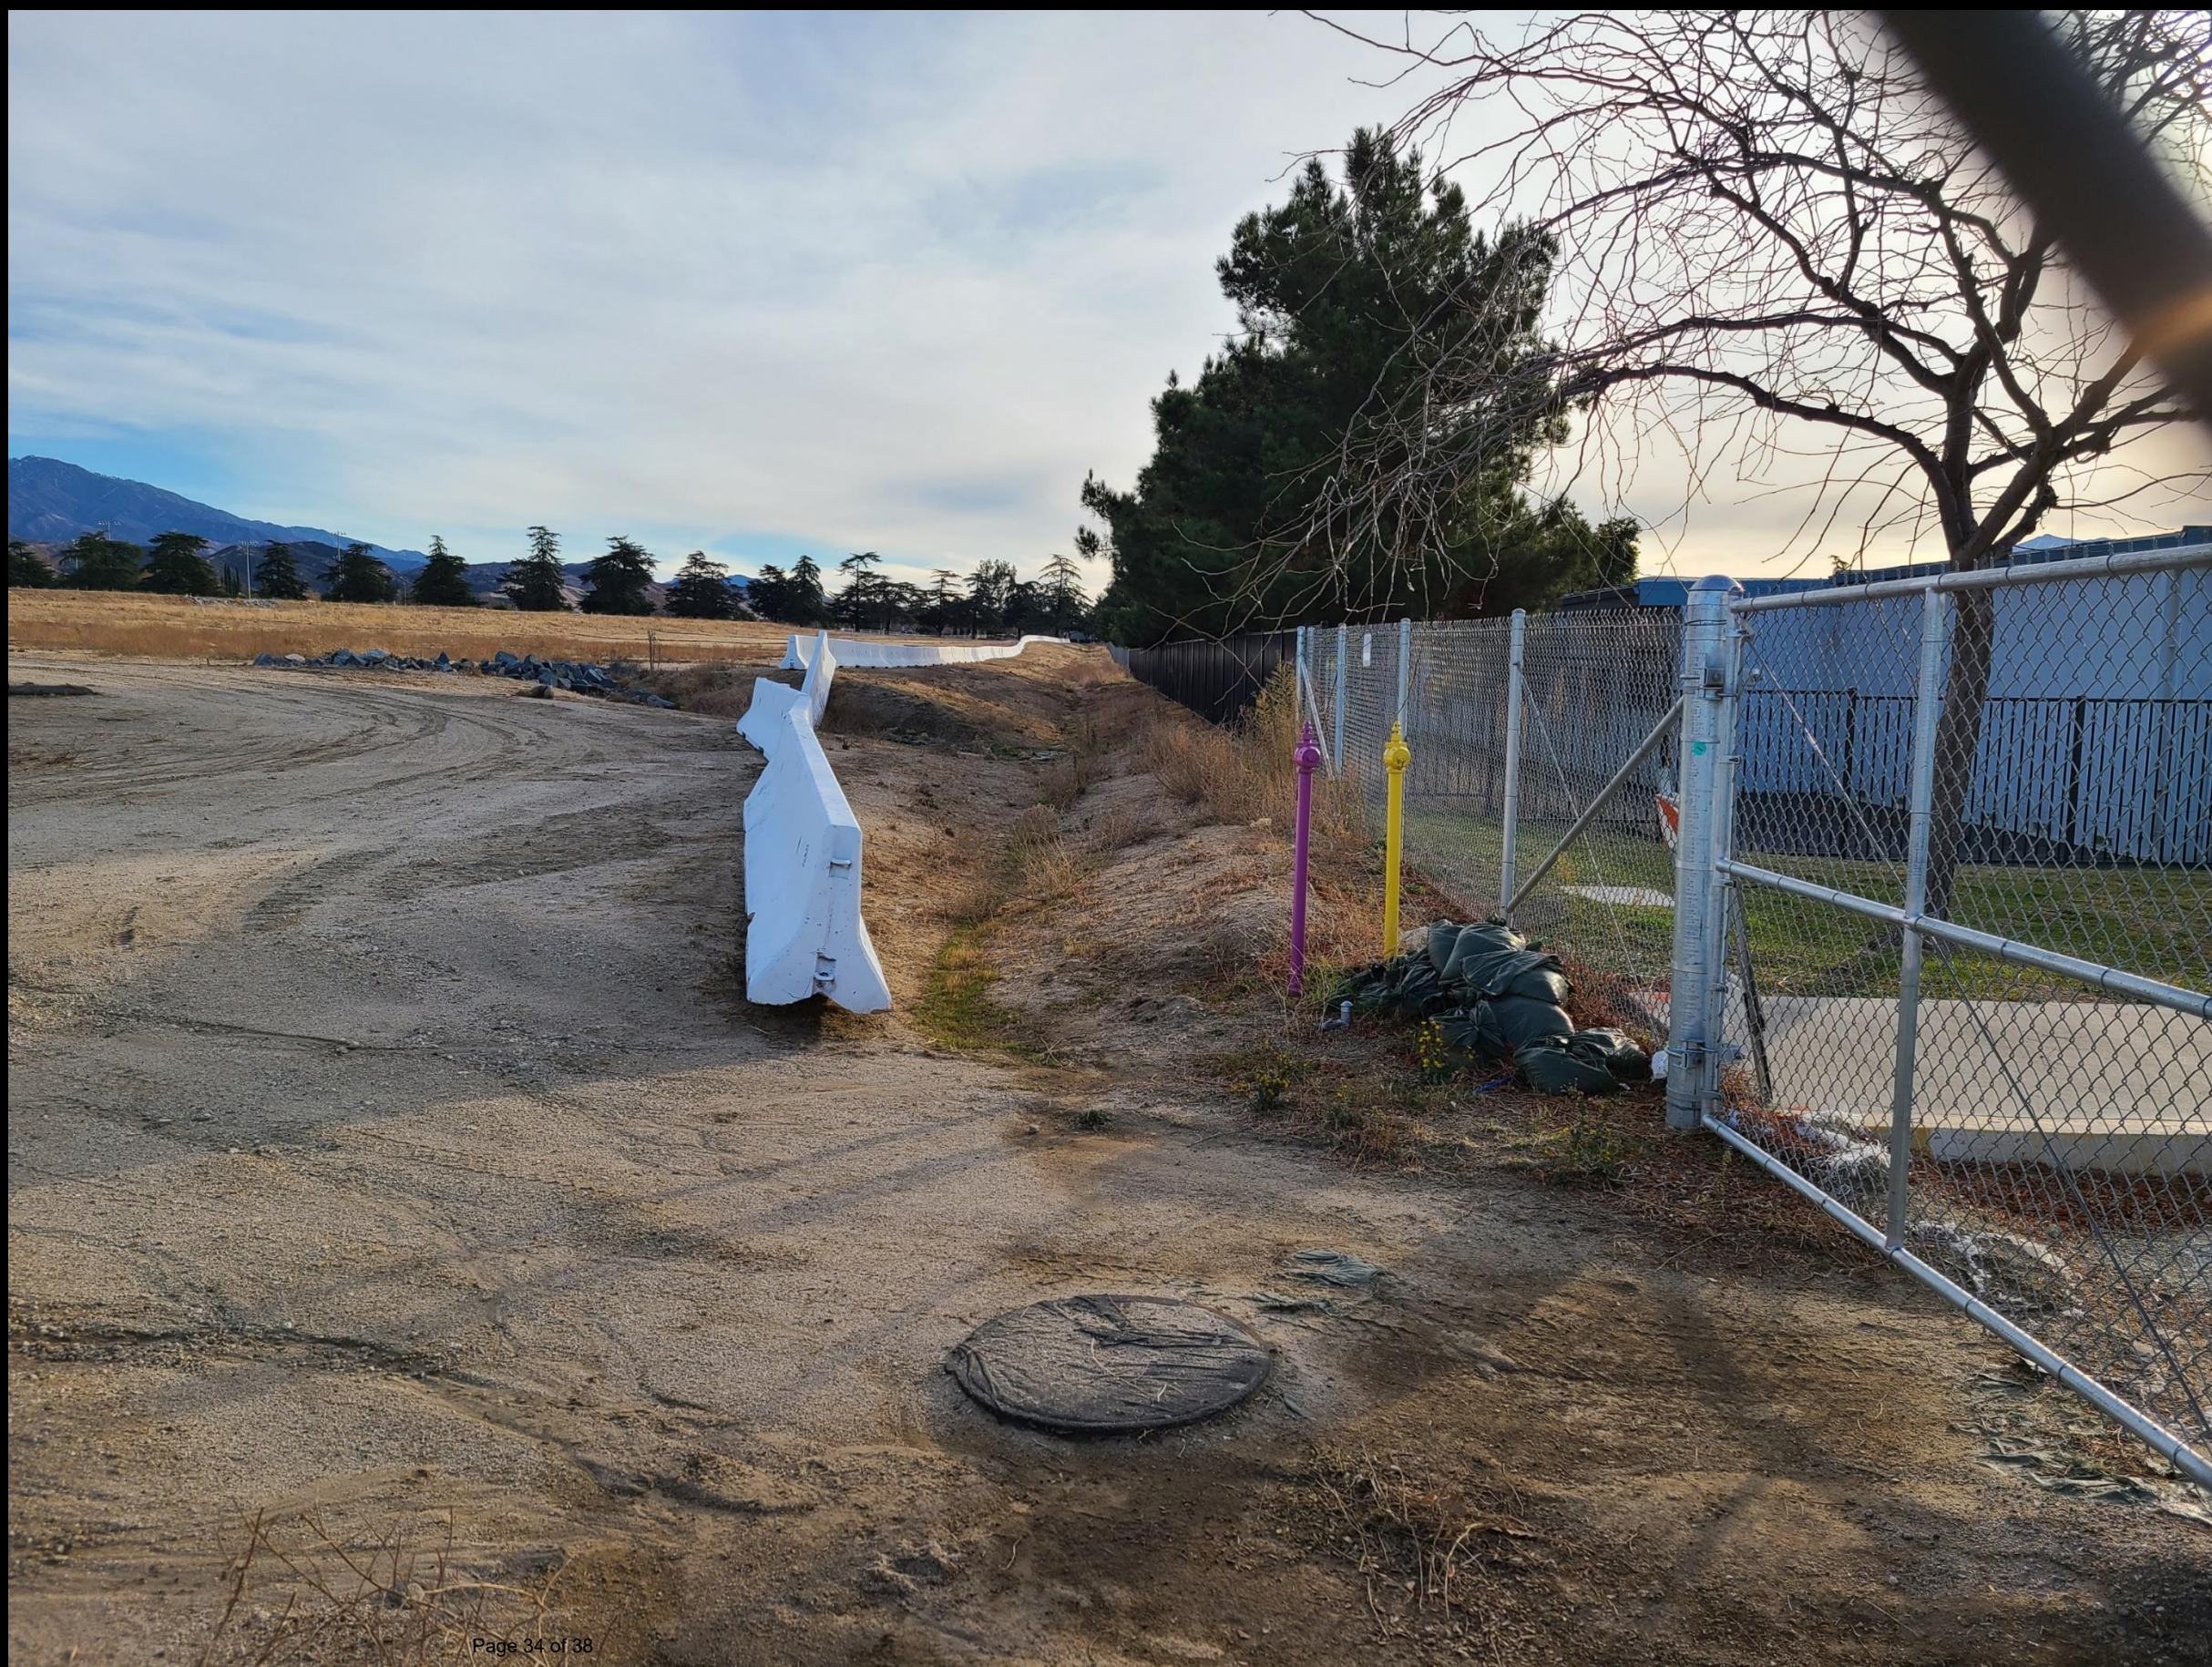
North of Mountain View Middle School

Looking East

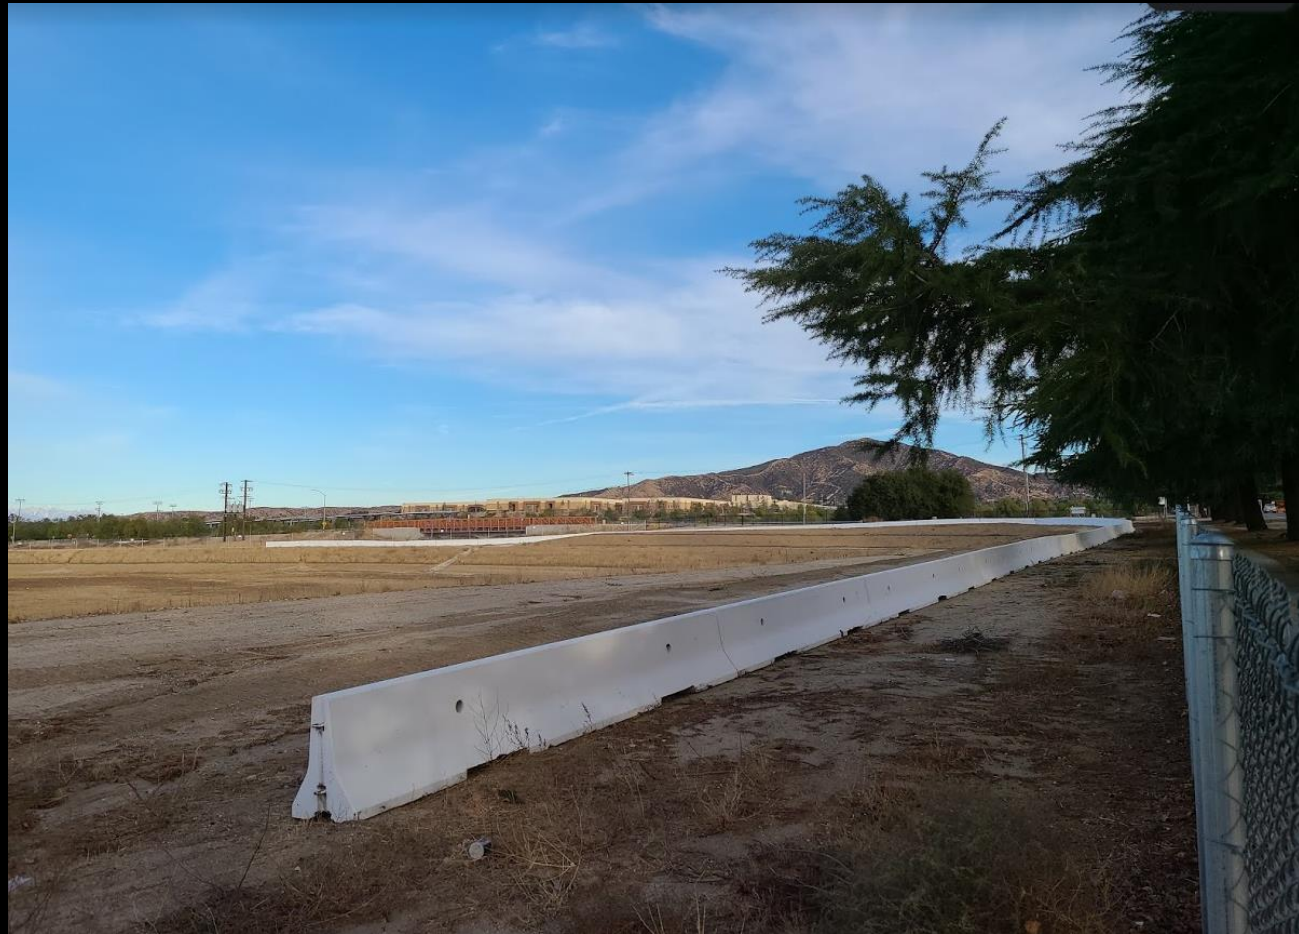
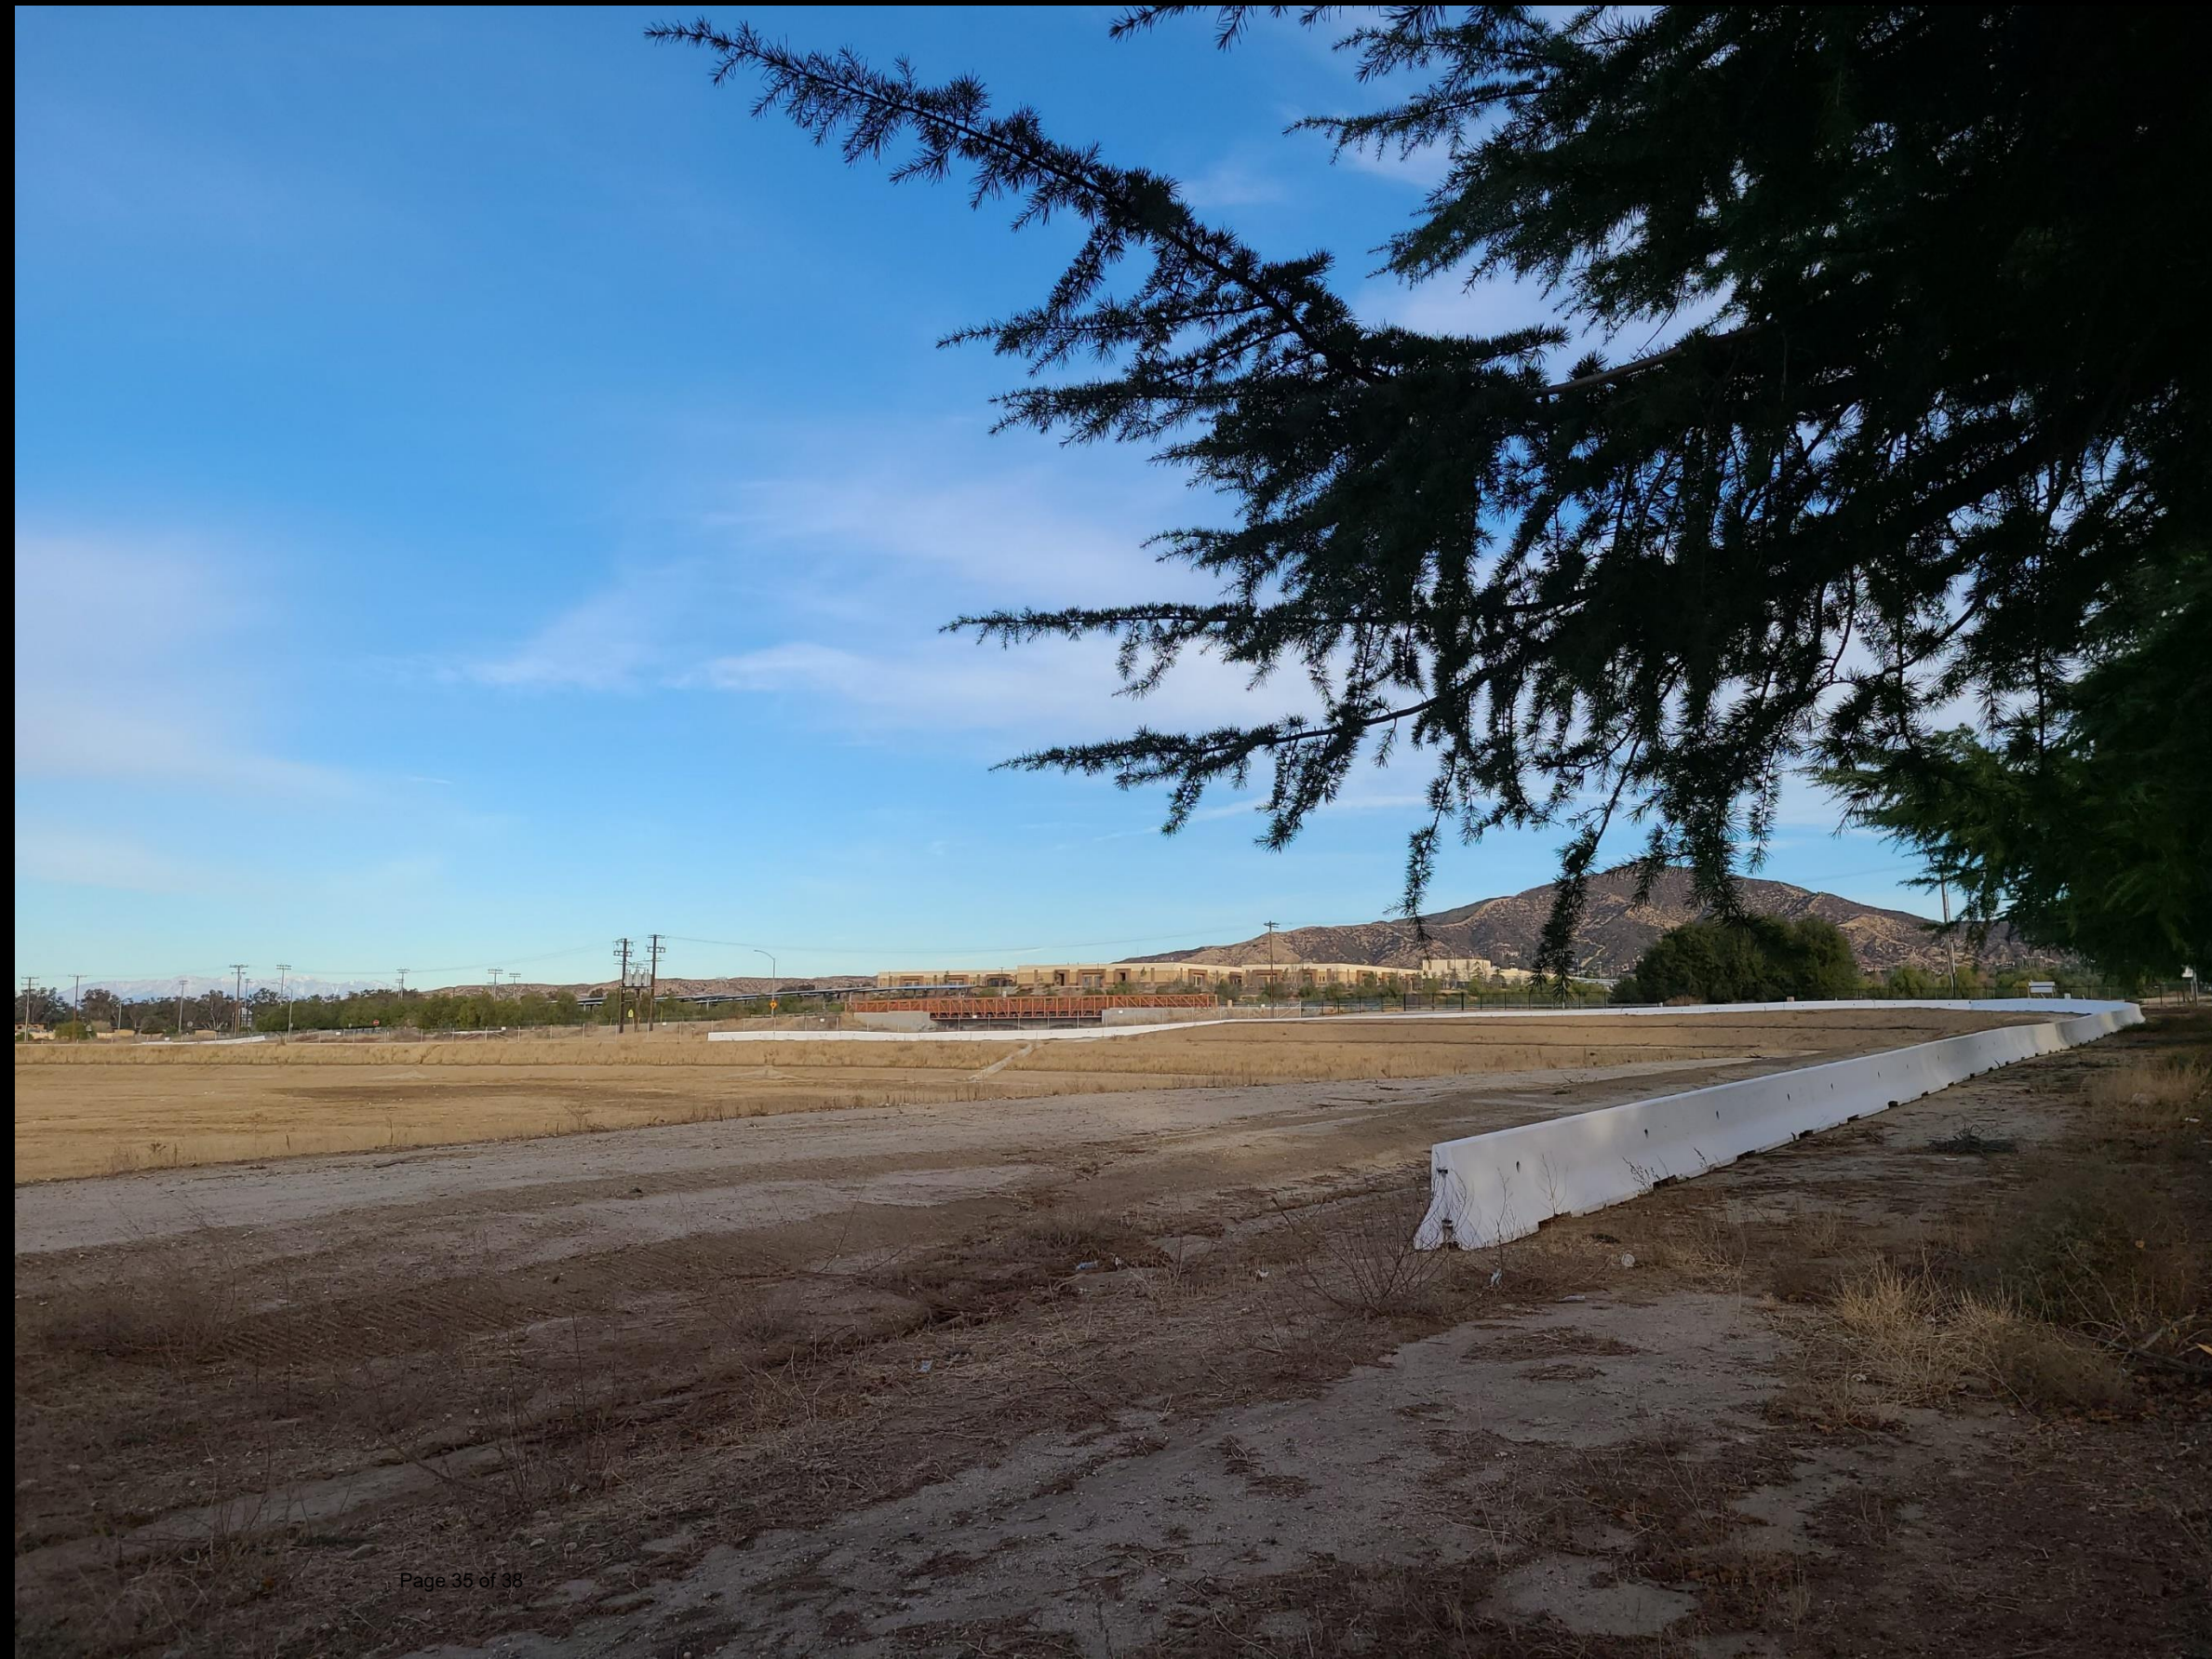
Pond 1

Looking Northwest
