Brookside Recharge Protection

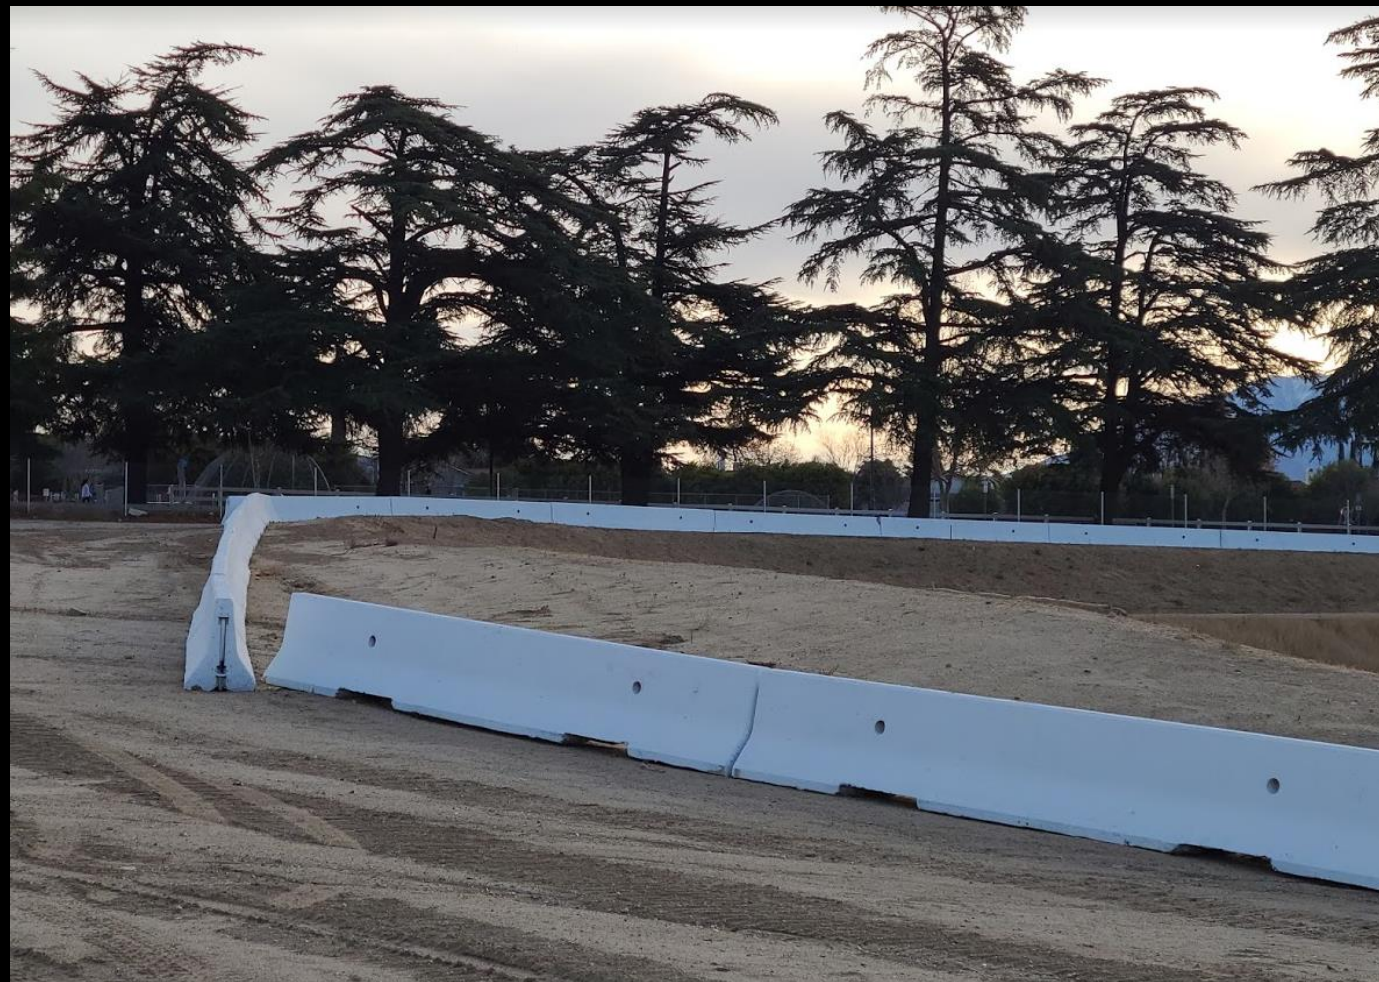
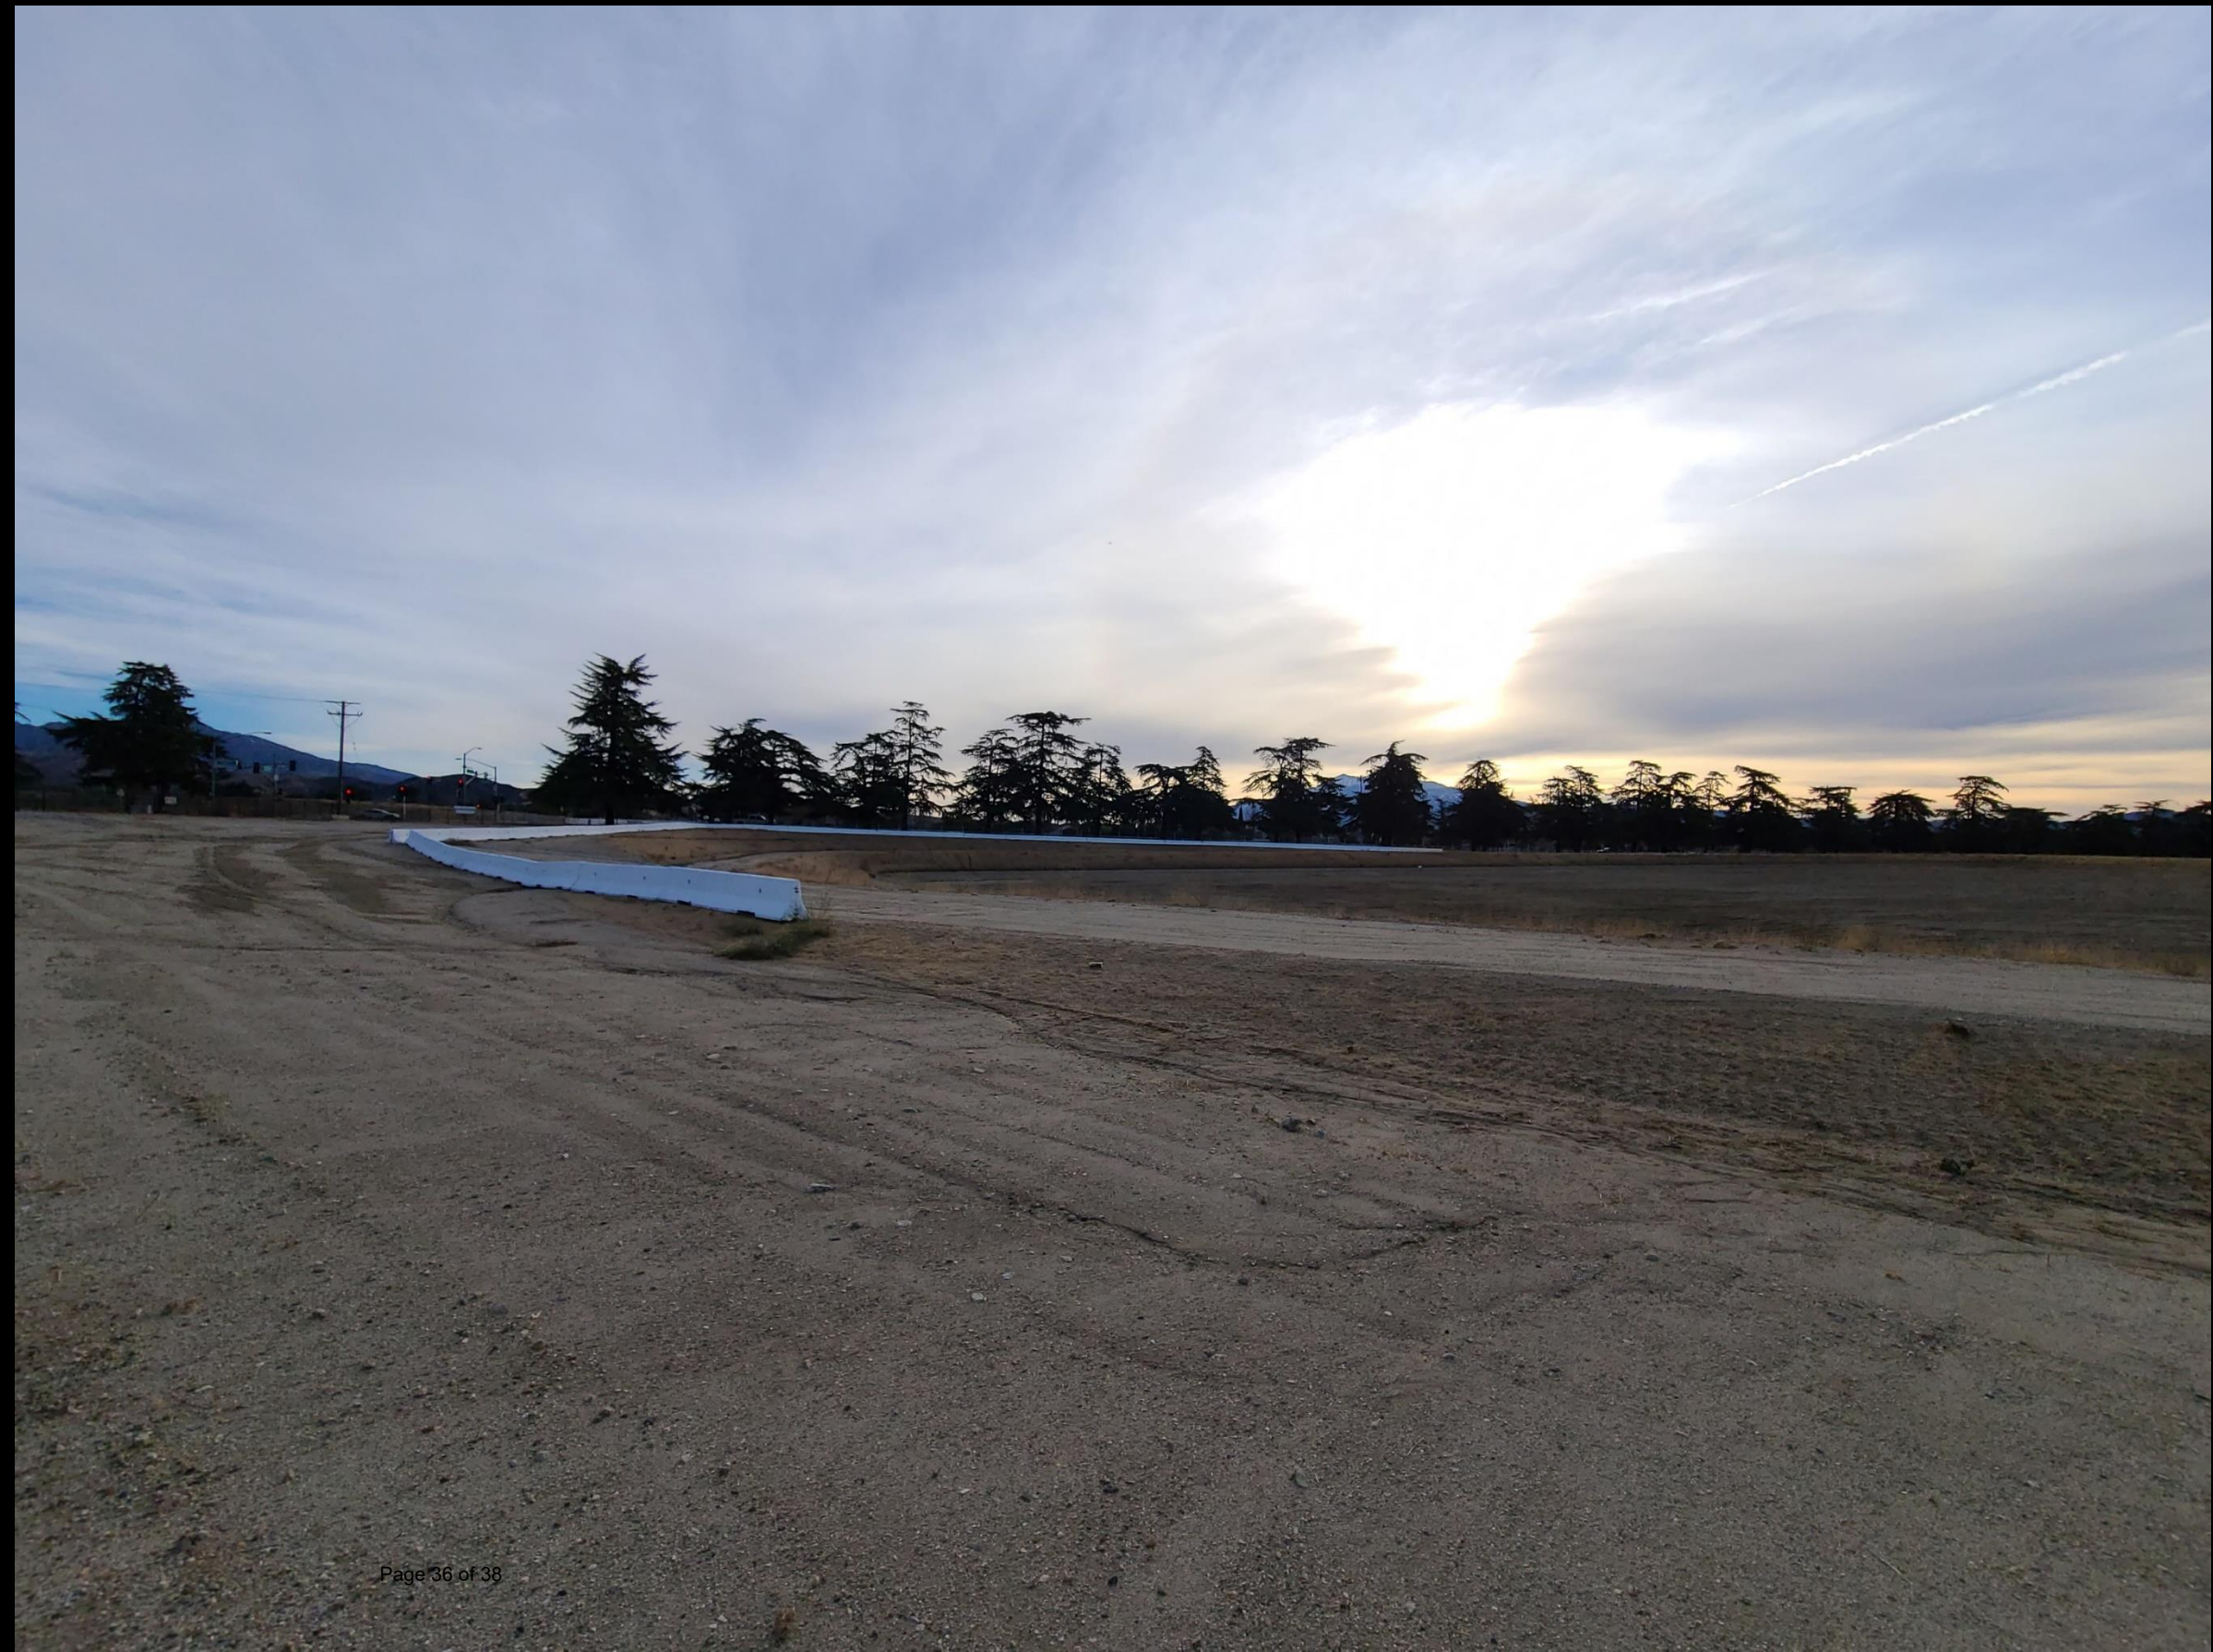
Pond 1

Looking East
